**Department of Informatics**

**Study of radiation effects  
in COTS semiconductors  
for use in high energy  
physics experiments**

**Cand. Scient Thesis**

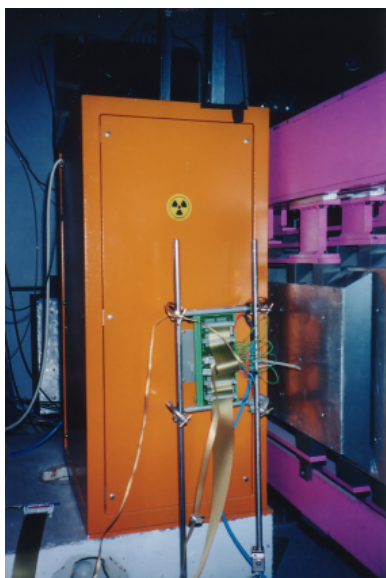
**Figure 4.9:** Picture of the ELMB setup used at the second GIF test.

The third TID test was also done at the GIF. Also in this test the ELMB was placed at a distance of about 25cm from the source, but the source was not on all the time. The idea was to create an annealing effect between each irradiation period, and see if this changed the current drawn by the ELMB. The analog input channels was connected to the same voltage divider fixture as in the first GIF test, but now only the outermost buffered reference voltage was used. Also the PT-100 temperature sensor was placed close to the ELMB board. In this test the distribution box was not used. Instead a new box was created. The idea of this box was that it should be easy and fast to install the measuring equipment (the box was intended to be used in the later SEE test). Also, it would be good to decrease the length of the cables from the current measuring LMB to the ELMB. The box has a CAN bus input connector, a CAN bus output connector and two power connectors for connection of two ELMBs. The LMB is also integrated into the box. The power is fed to the box via the CAN cable (one CAN power supply and a second supply for the analog/digital power). The box were placed inside the GIF radiation zone, but behind a block of concrete. The cable from the box (after the LMB) was now reduced from 30m down-to 3m. With this setup it was possible to measure six different currents and two temperatures (PT-100 sensors, 4-wire connection). In our setup the three currents and the ambient temperature inside the GIF was measured. The same desktop computer was used in this test, but the SCADA software was changed a bit. The computer had a network connection, and every second hour the application extracted the current measurement data and stored them in a file accessible through the web, for easy access to the measurement data.
